Swift Home Inspection

Confidential - Property Inspection Report - Confidential

3031 S Sample St, Mesa, AZ 85212
Inspection prepared for: John Smith & Jane Smith
Real Estate Agent: Support - Home Inspector Pro

Date of Inspection: 9/5/2012 Time: 2:00
Age of Home: 1997 Size: 2039

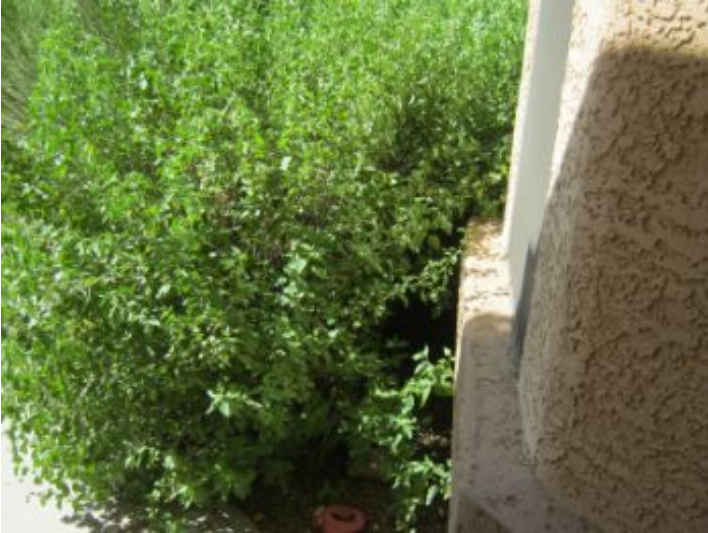
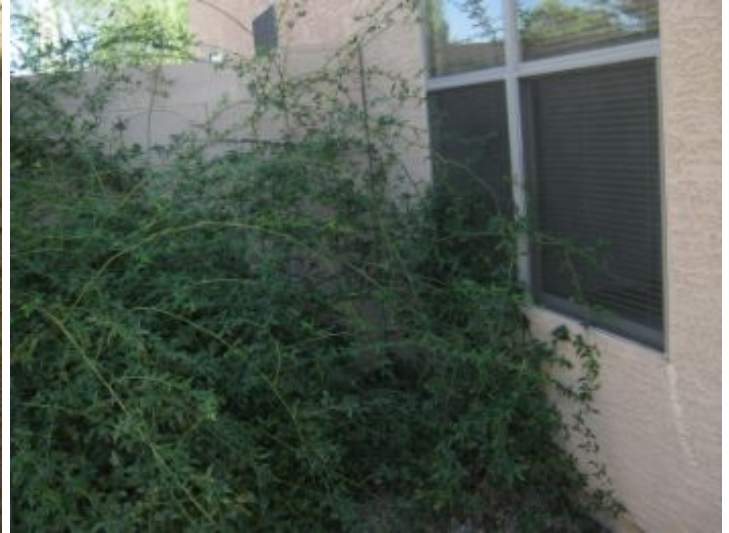
2. Vegetation Affecting Structure

- Vegetation is encroaching on the structure.

- Vegetation too close to the building can cause harm through root damage to the foundation, branches abrading the roof and siding, and leaves providing a path for moisture and insects into the home.

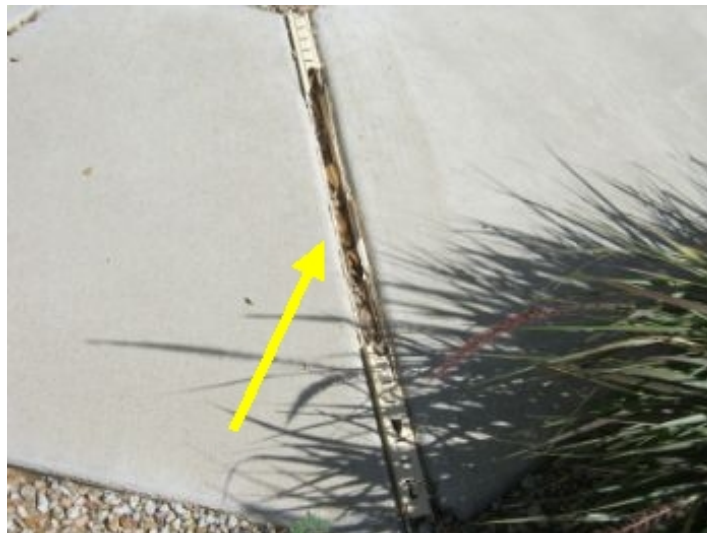
4. Walkways

- Functional - except as noted. The drainage grate is deteriorated and should be repaired.

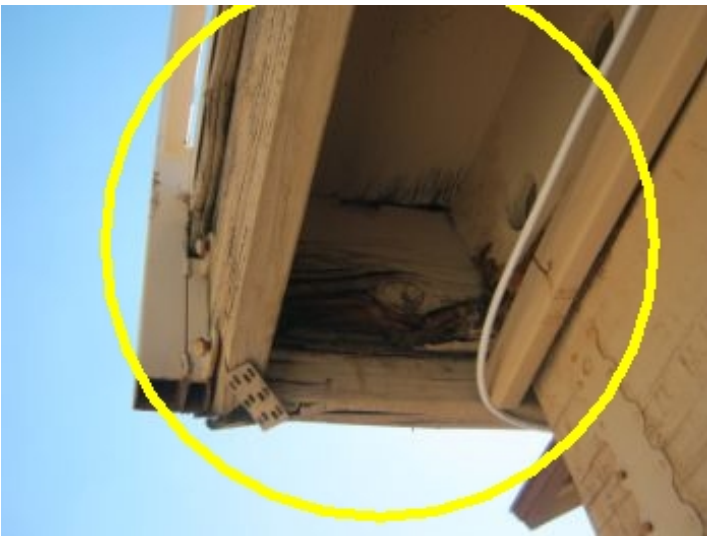
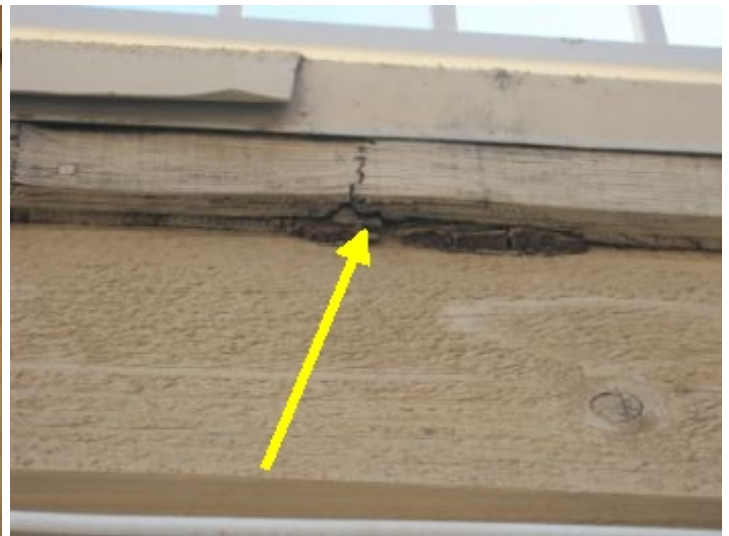
8. Deck and Balcony

- We noted multiple areas with deteriorated wood. Recommend further evaluation.

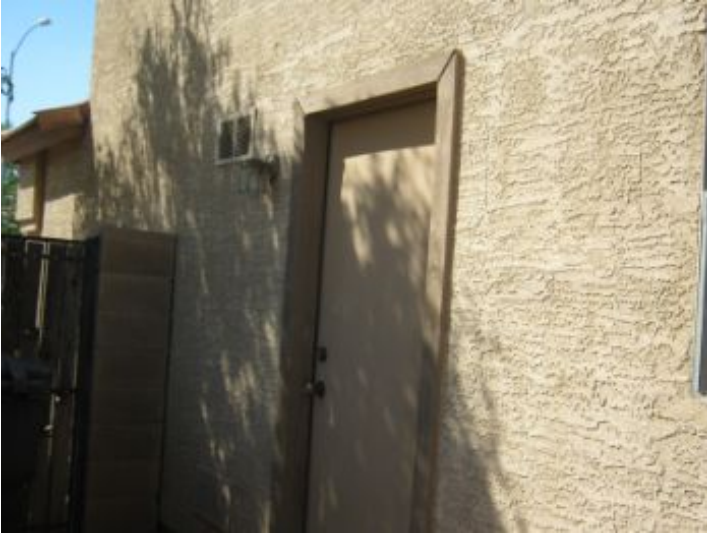
Garage side door exterior trim and door jam are deteriorated. We recommend repair.

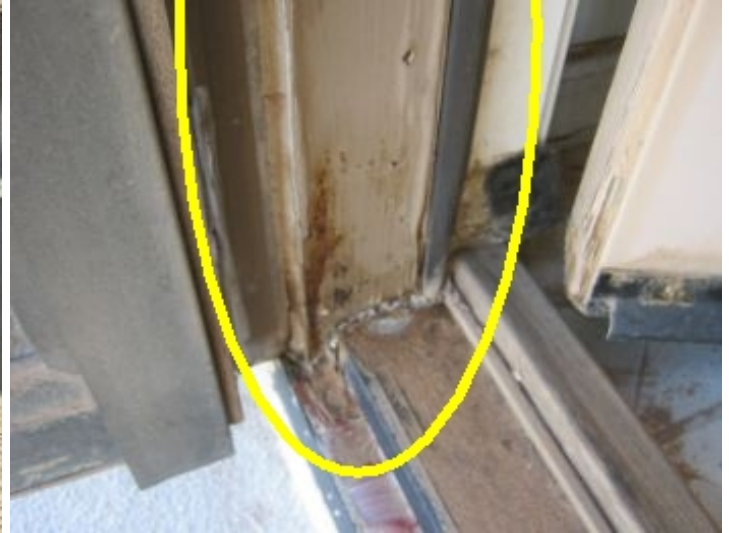
The master bedroom balcony door jam is deteriorated and we also noted damaged to the sub-floor at the inside of the door. We recommend further evaluation and remedy by a competent contractor.

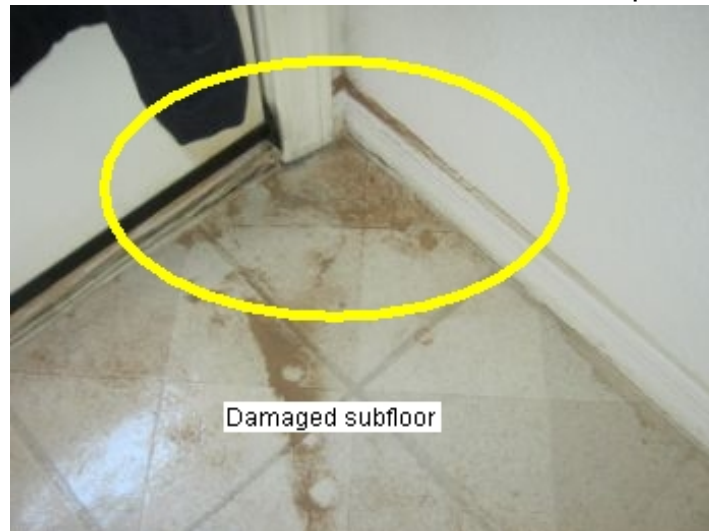
Damaged subfloor

The master bedroom balcony door jam is deteriorated and we also noted damaged to the sub-floor at the inside of the door. We recommend further evaluation and remedy by a competent contractor.

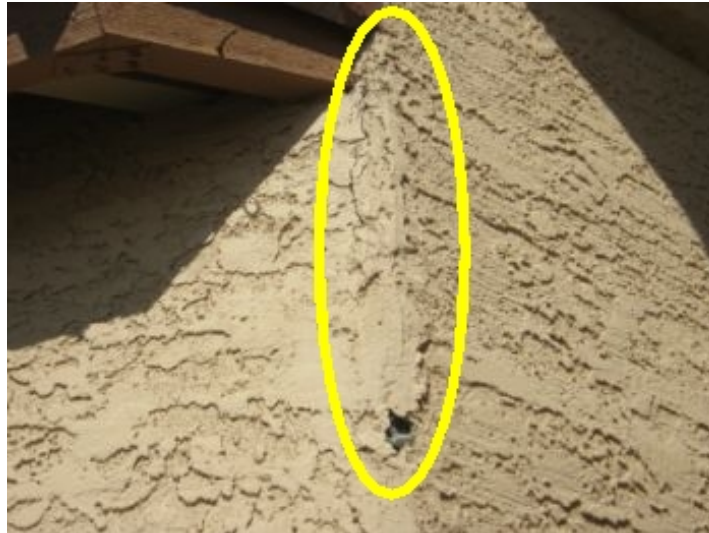
10. Exterior Walls

- Areas that need typical maintenance and paint.

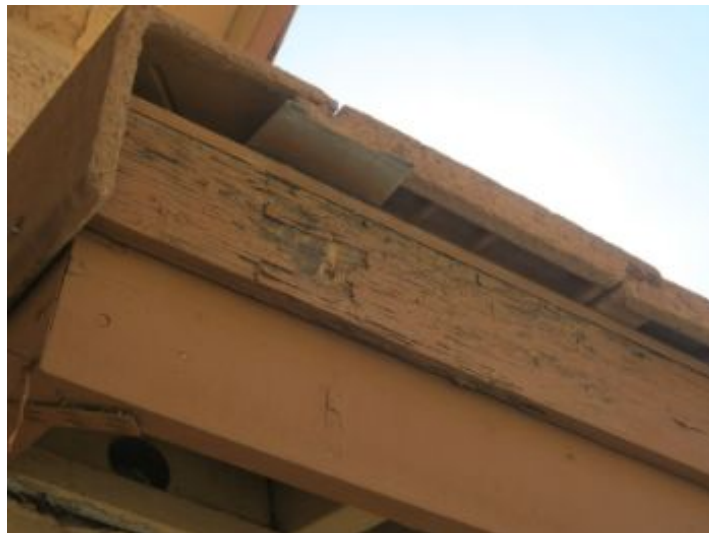
We noted areas needing typical maintenance and some dry rotted areas. We recommend further evaluation.

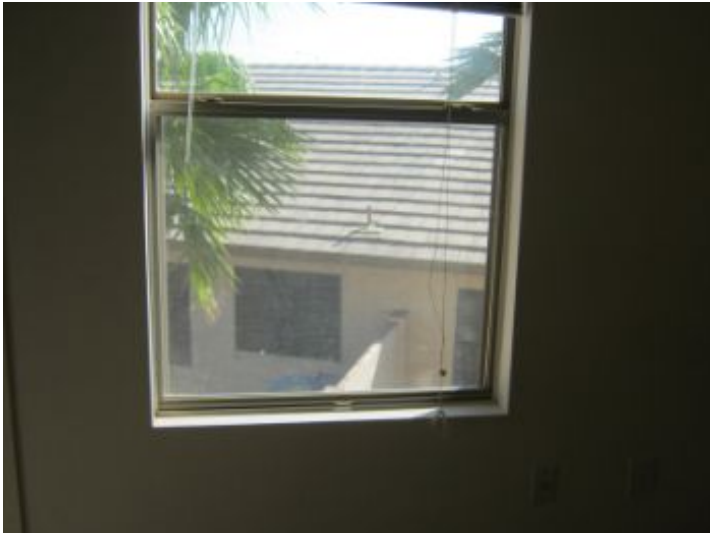
Several windows do not hold themselves open(right rear bedroom & dining room).

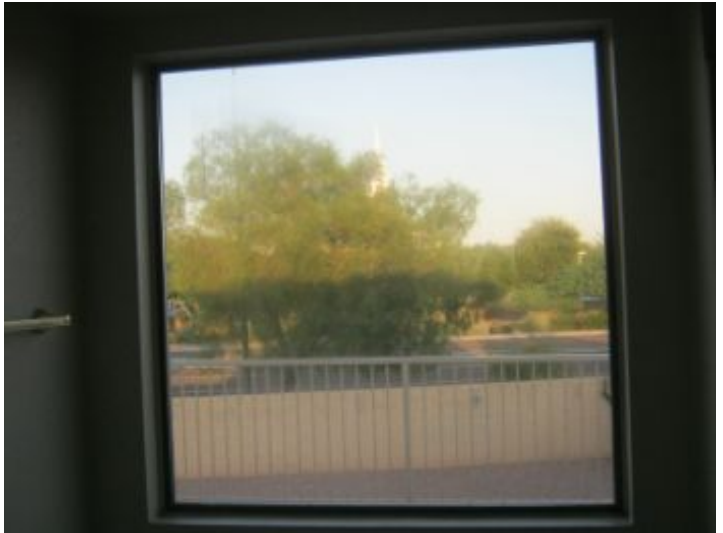
Broken seal(master bath).

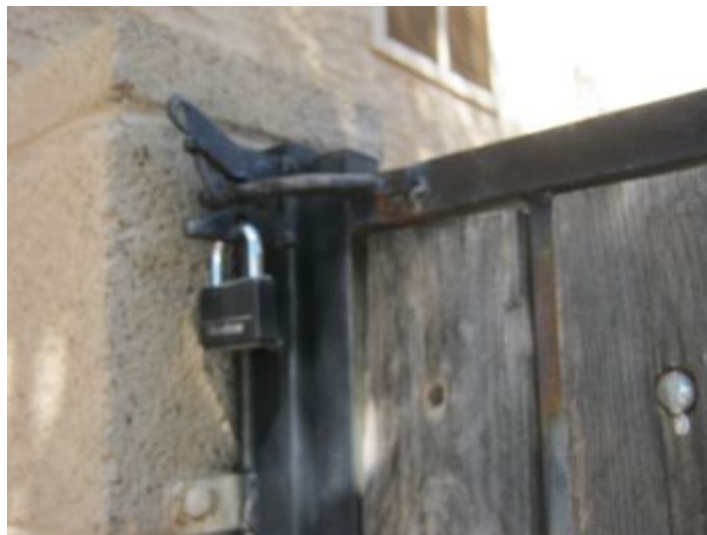
Gate was locked and could not be operated.

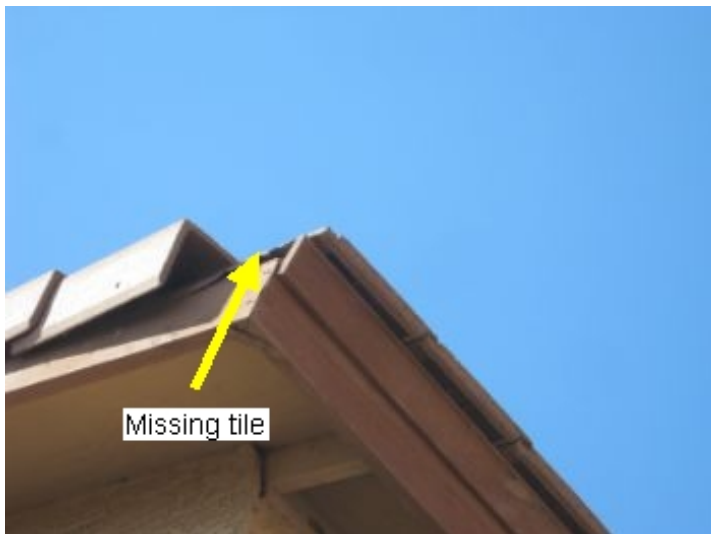
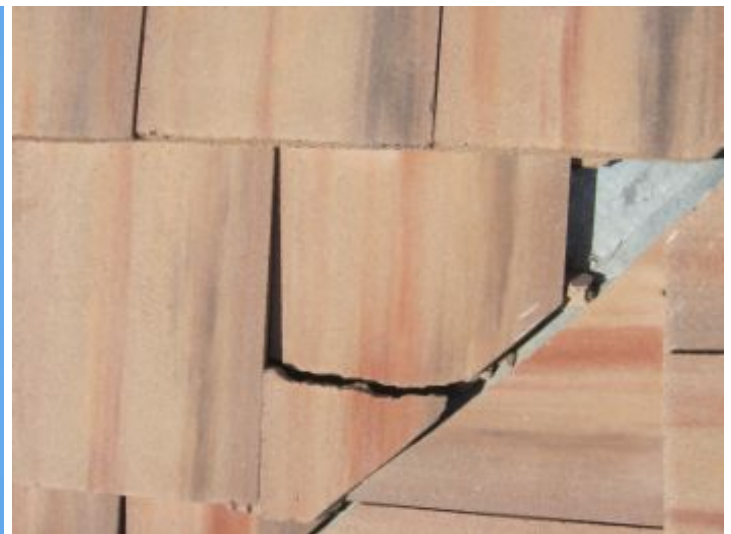
2. Roof Covering

- Several cracked, broken and or missing tiles that should be replaced.
- We noted several moisture stains on the interior which may be indicative of roofing failures that should be serviced by a competent roofing contractor.

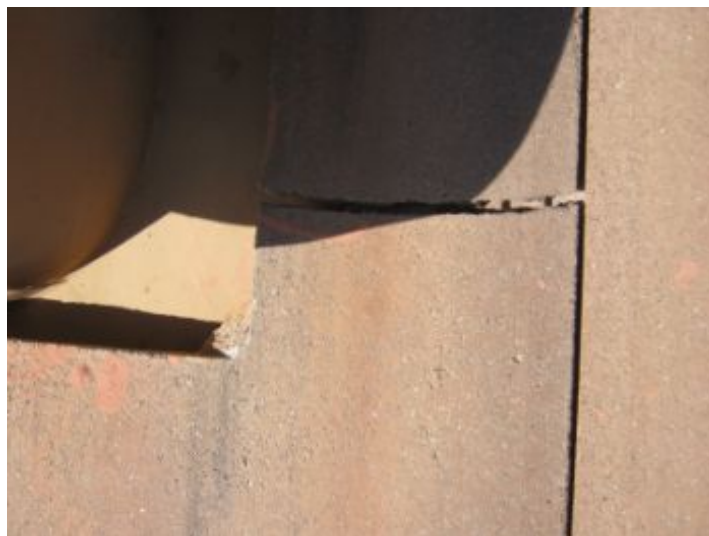
Several cracked or broken tiles that should be replaced.

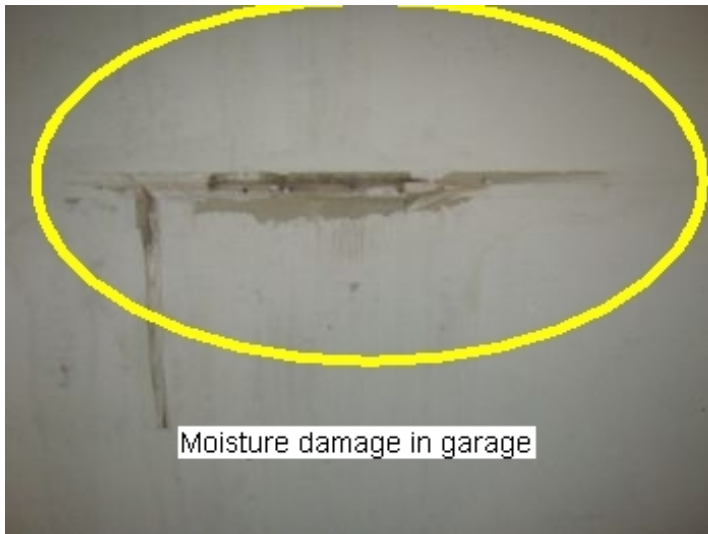
Moisture damage in garage

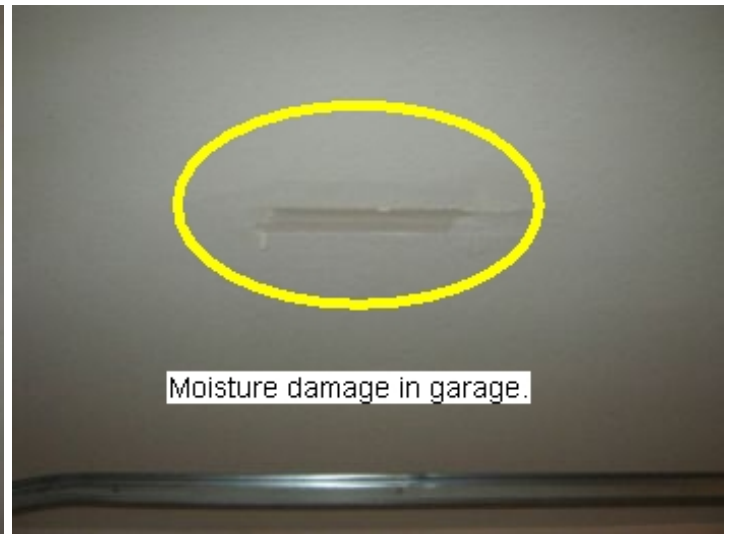
Moisture damage in garage.

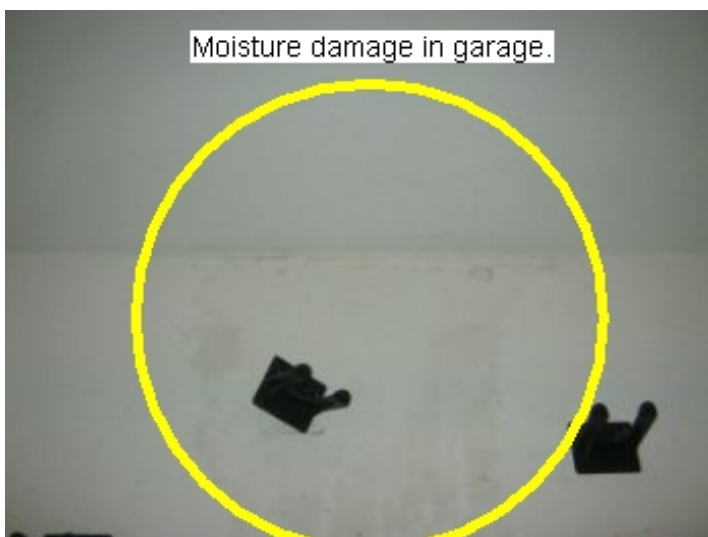
Moisture damage in garage.

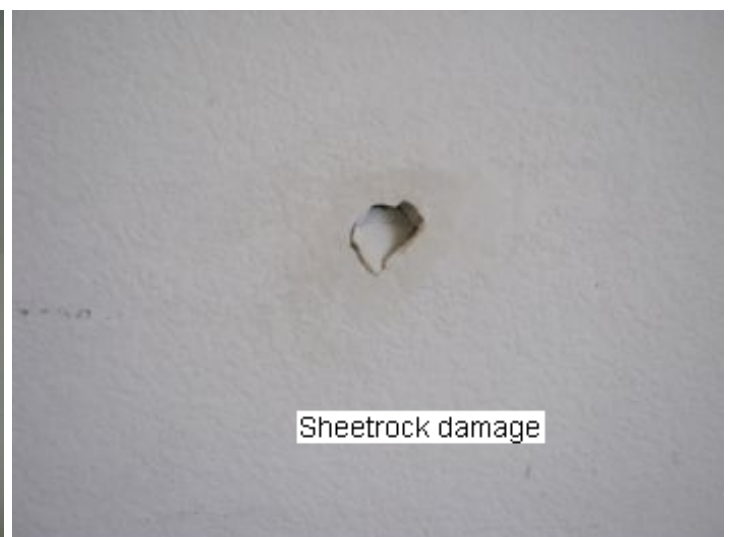
Sheetrock damage

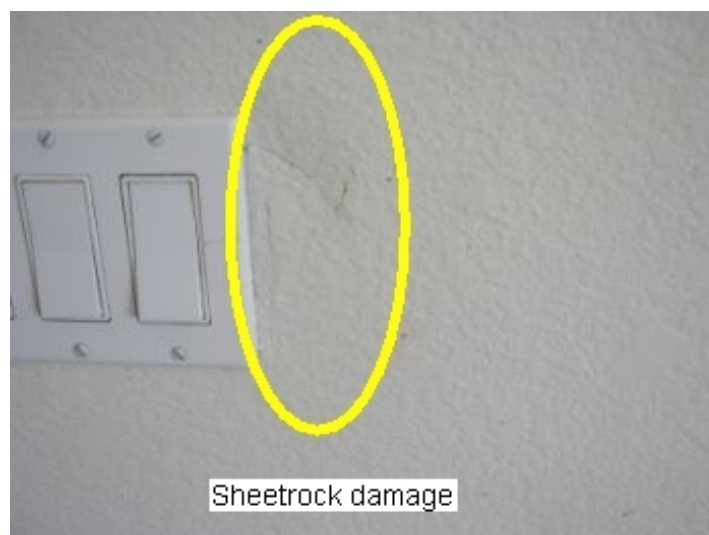
Sheetrock damage

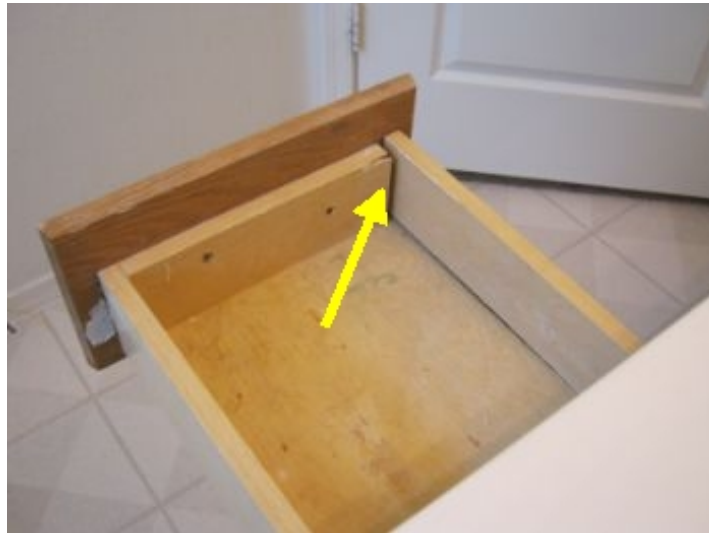
Damaged drawer(s)(hallway bath).

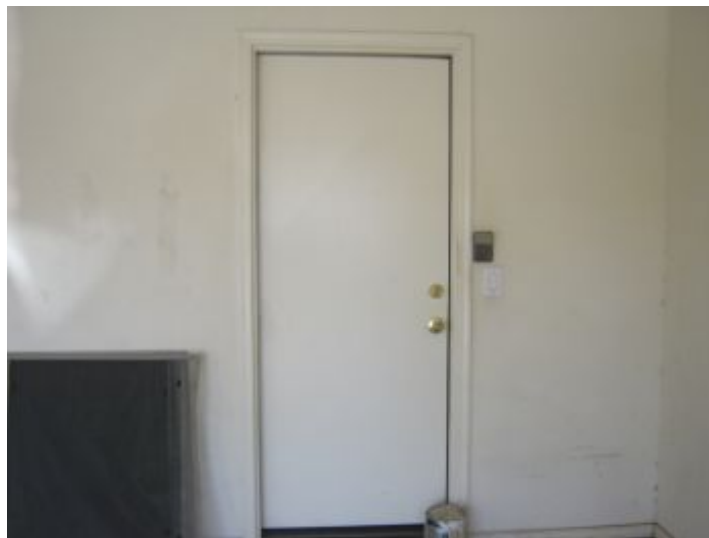
- RED: The automatic closure device does not close the door properly. This could allow a fire to enter the home. Recommend adjusting or replacing the hinges to allow for proper closure of the door.

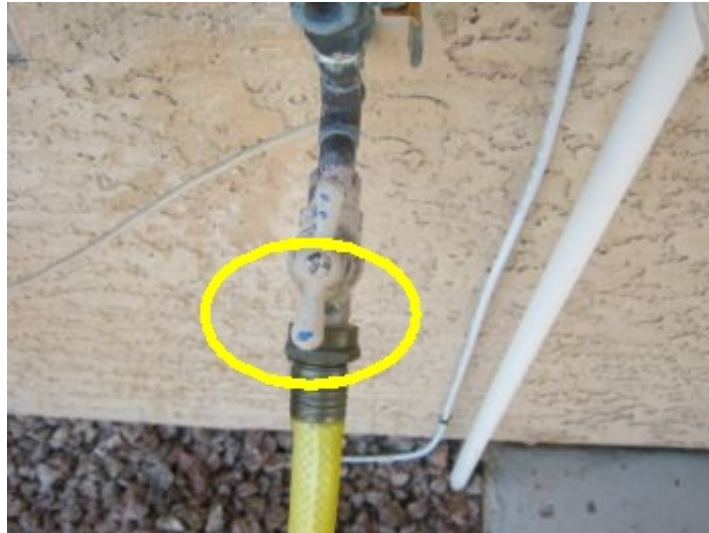
IMPROVE: There are no anti siphon devices at the exterior faucets. This is a potential cross contamination. Recommend installing anti siphon devices.

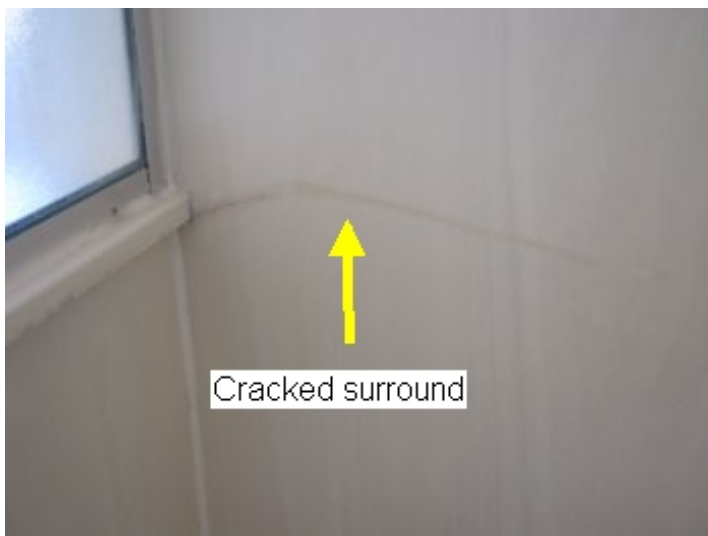
The surround is cracked and may leak. We recommend repair/replacement.

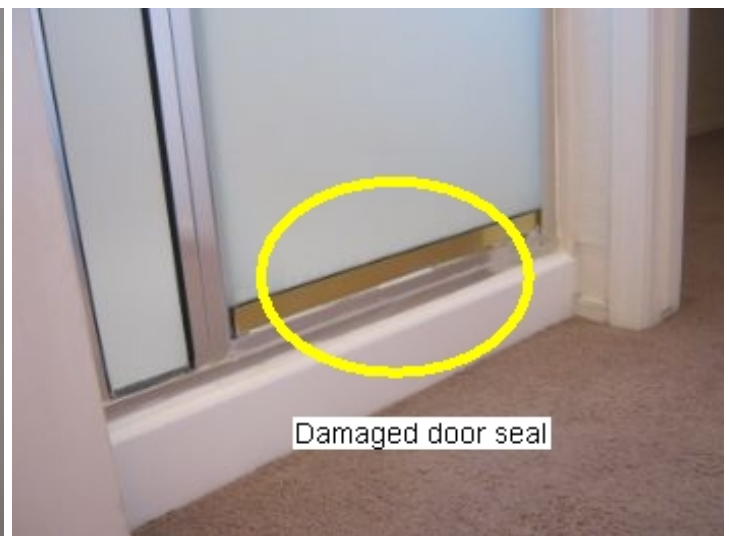
The seal at the bottom of the shower door is damaged and should be replaced.

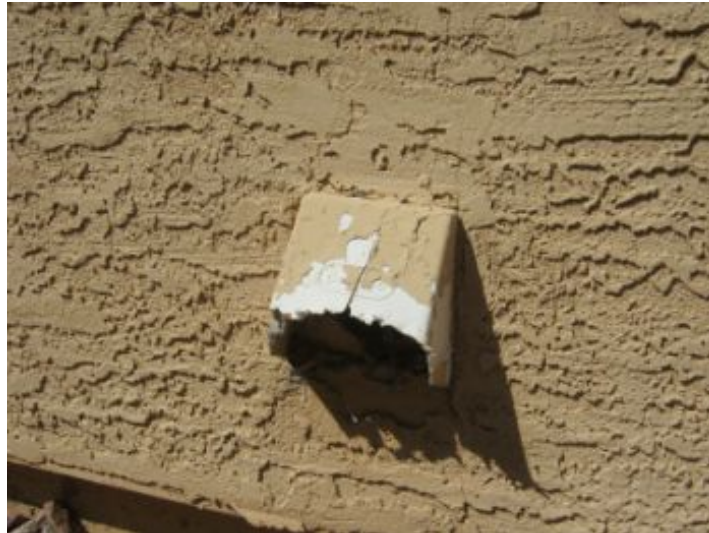
- Damaged exterior cover

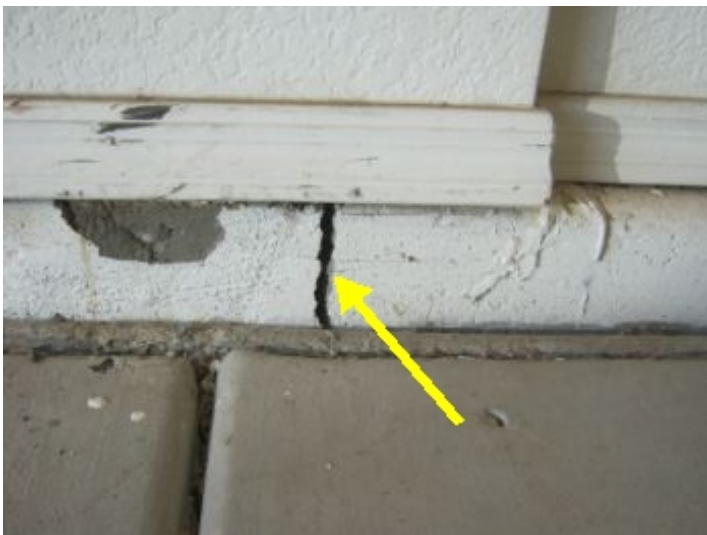
RED: Vertical cracks should be further evaluated(garage, entry and bay window areas).

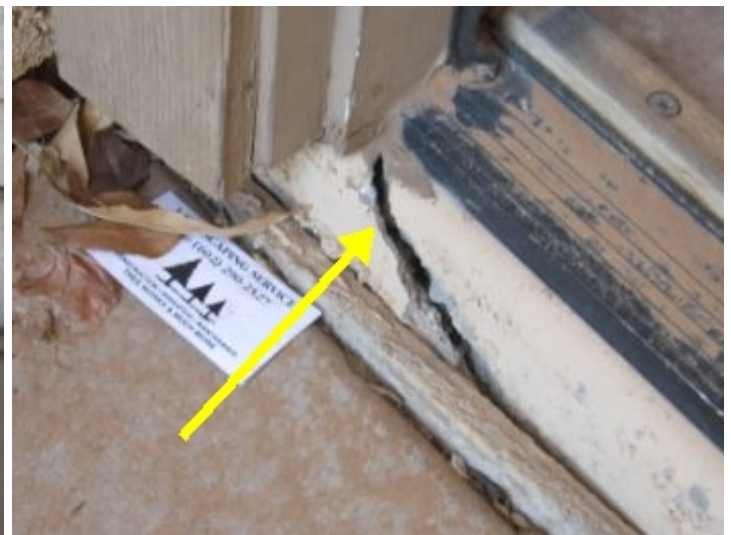
RED: Vertical cracks should be further evaluated(garage, entry and bay window areas).

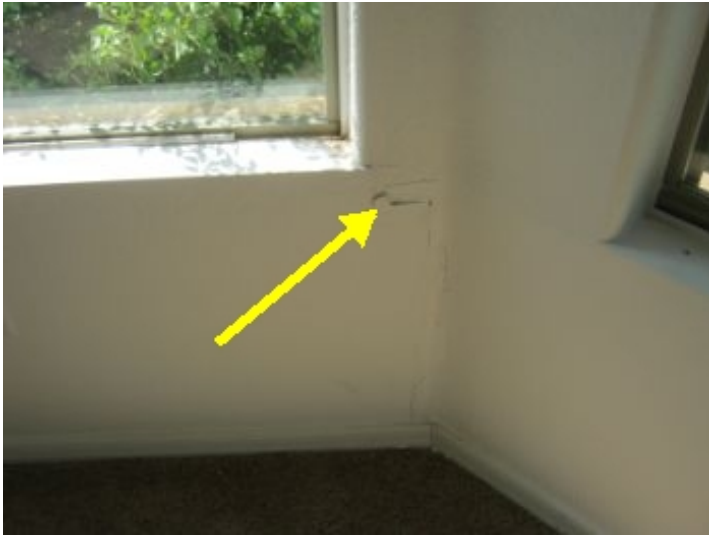
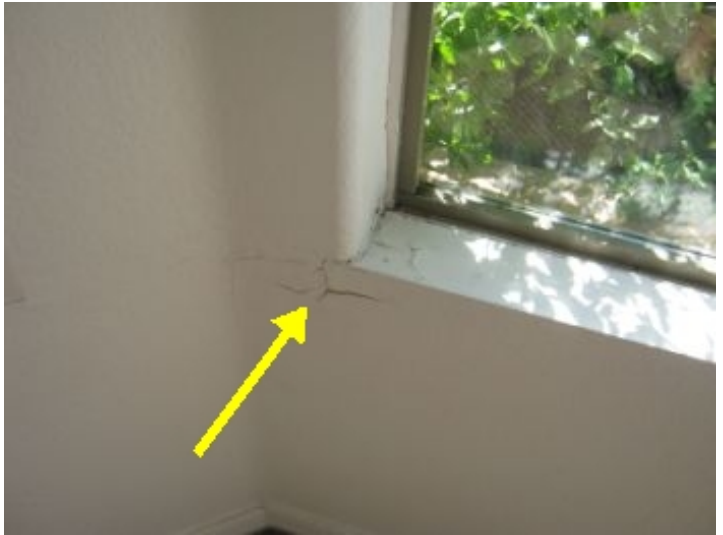
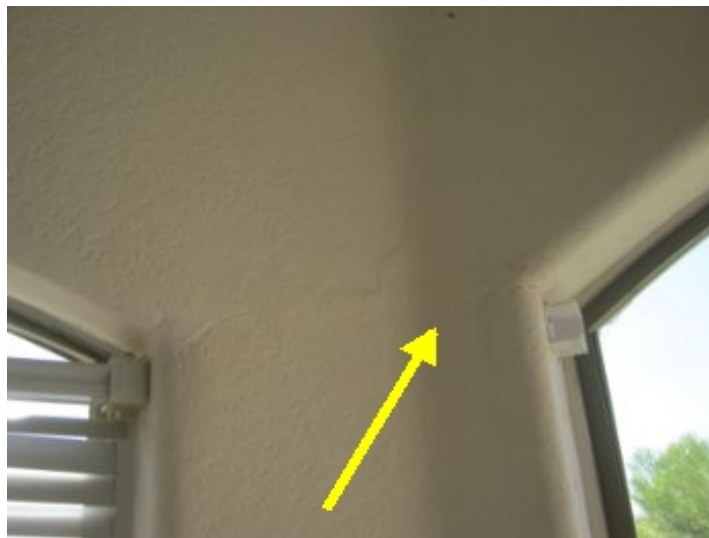
2. Foundation Observations

- RED: Vertical cracks should be further evaluated(garage, entry and bay window areas).

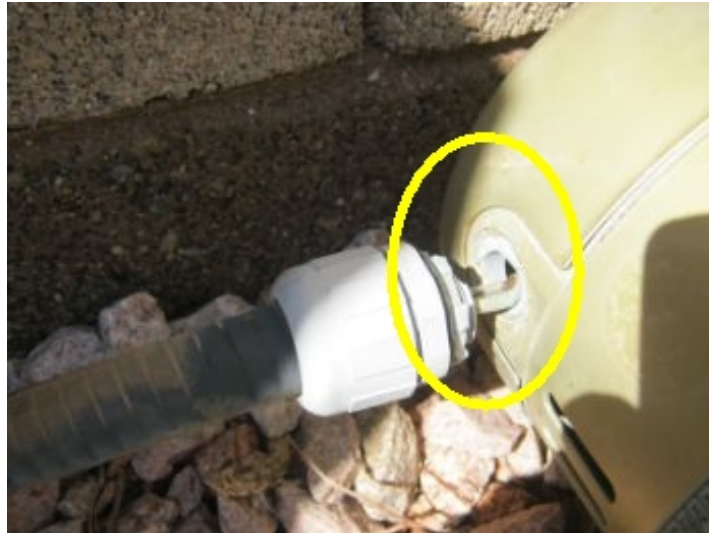
- The electrical conduit to the motor is damaged and wires are exposed. We recommend repair.

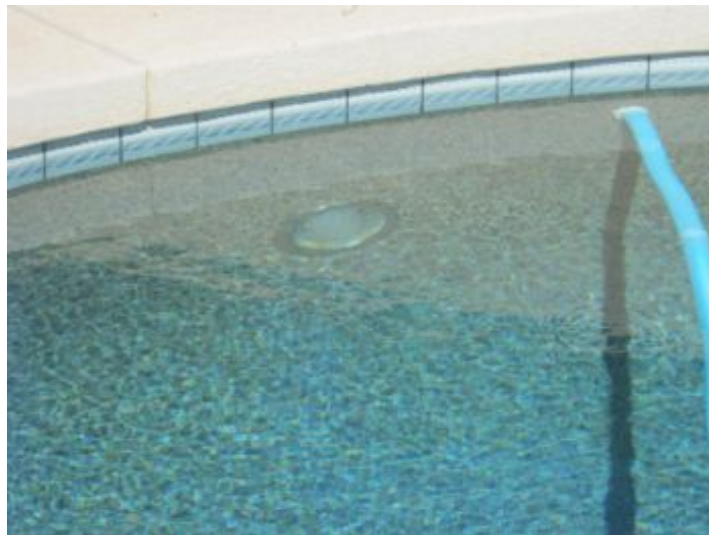
6. Pool Light

- Pool light did not respond.
- Could not verify if pool light is on GFCI circuit. We recommend further evaluation as this is a safety issue.

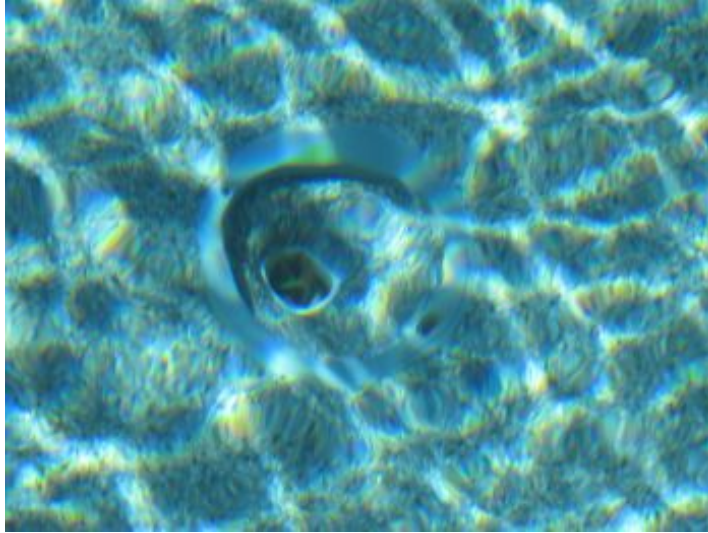
- Drain cover is missing and should be replaced with a proper anti-vortex type cover.
